**DOT/FAA/TC-22/35**

# **Small Unmanned Aircraft System for Pavement Inspection: Task 4—Execute the Field Demonstration Plan and Analyze the Collected Data**

November 2022

Final Report

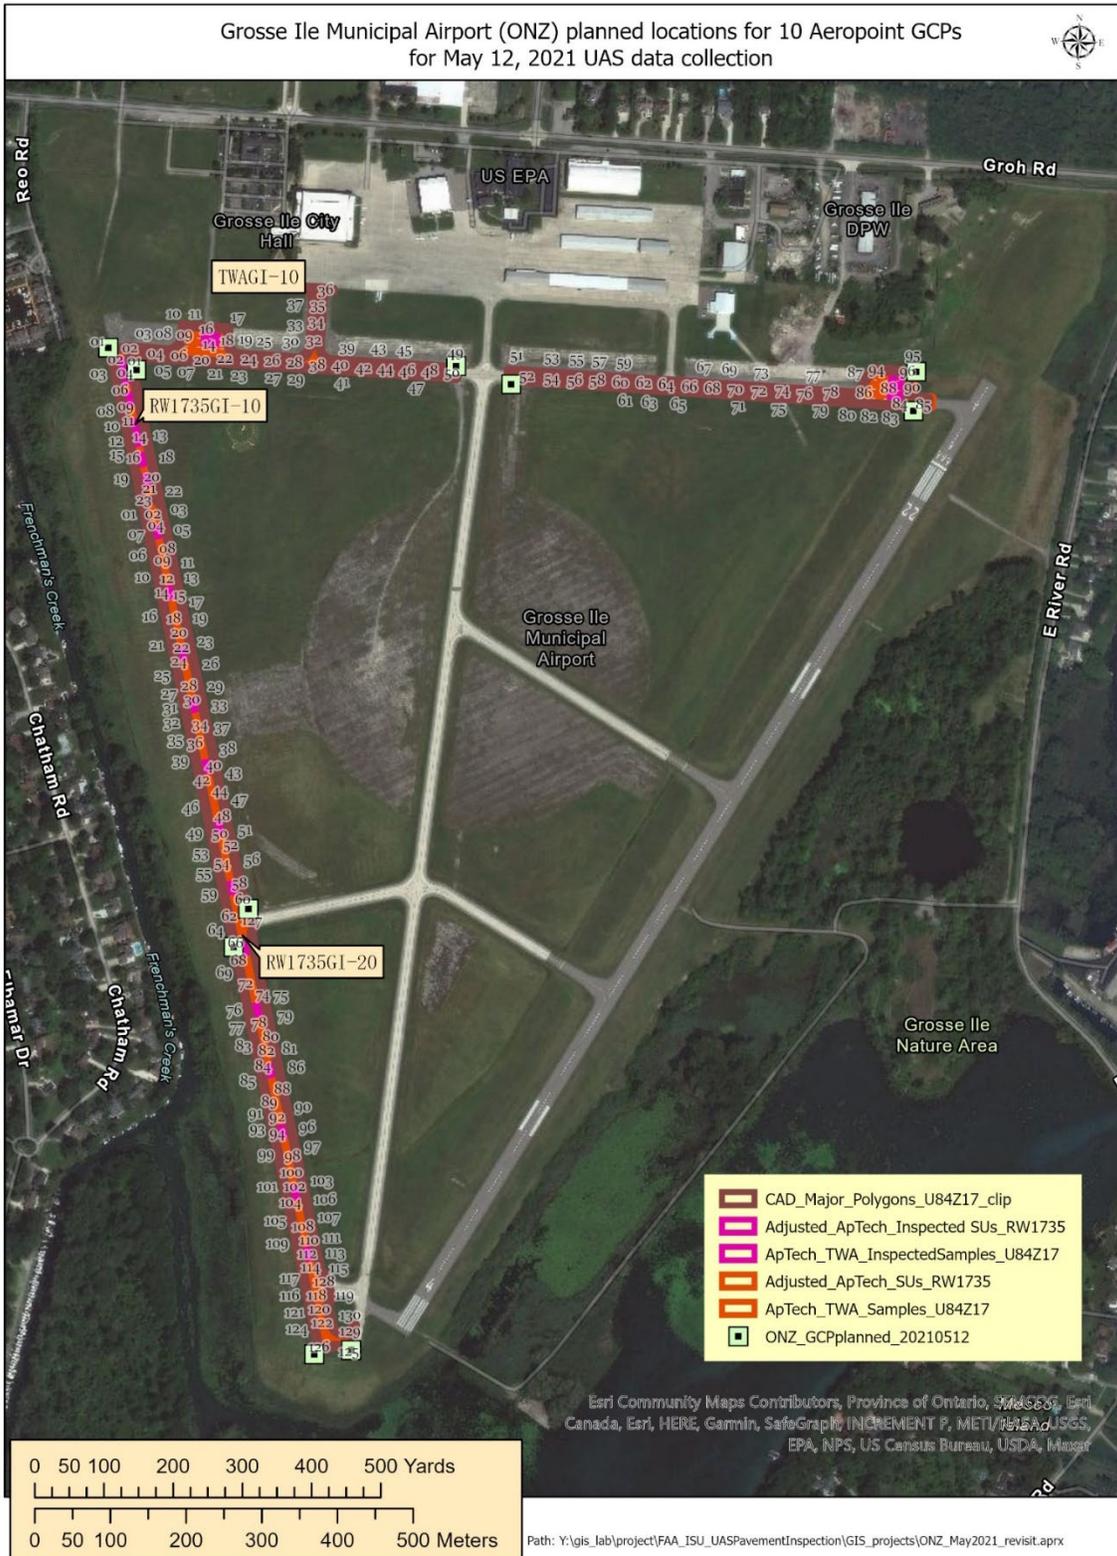
Figure 2. Recommended Locations for GCPs at ONZ

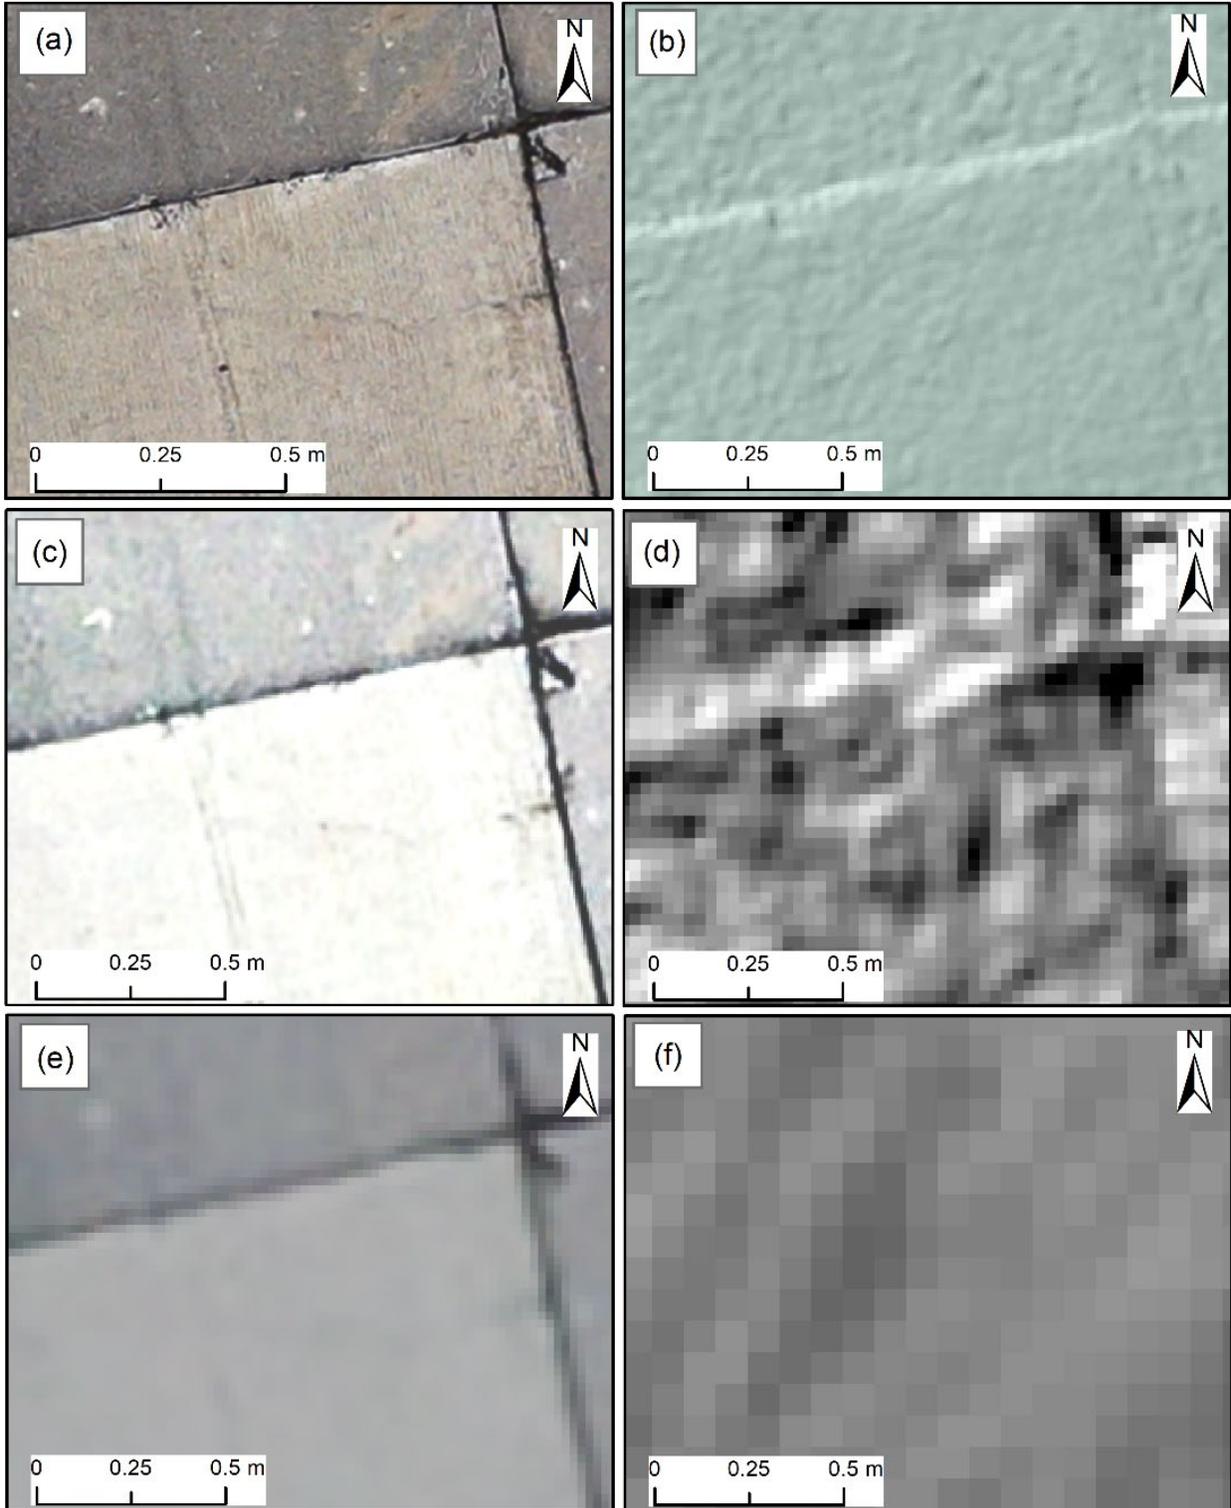
Figure 3. Low-severity Corner Break and Medium-severity Faulting in (a) 2.5-mm/pix Orthophoto, (b) 10-mm/pix DEM, (c) 7.2-mm/pix Orthophoto, (d) 29.1-mm/pix DEM, (e) 21-mm/pix Orthophoto, and (f) 84-mm/pix DEM

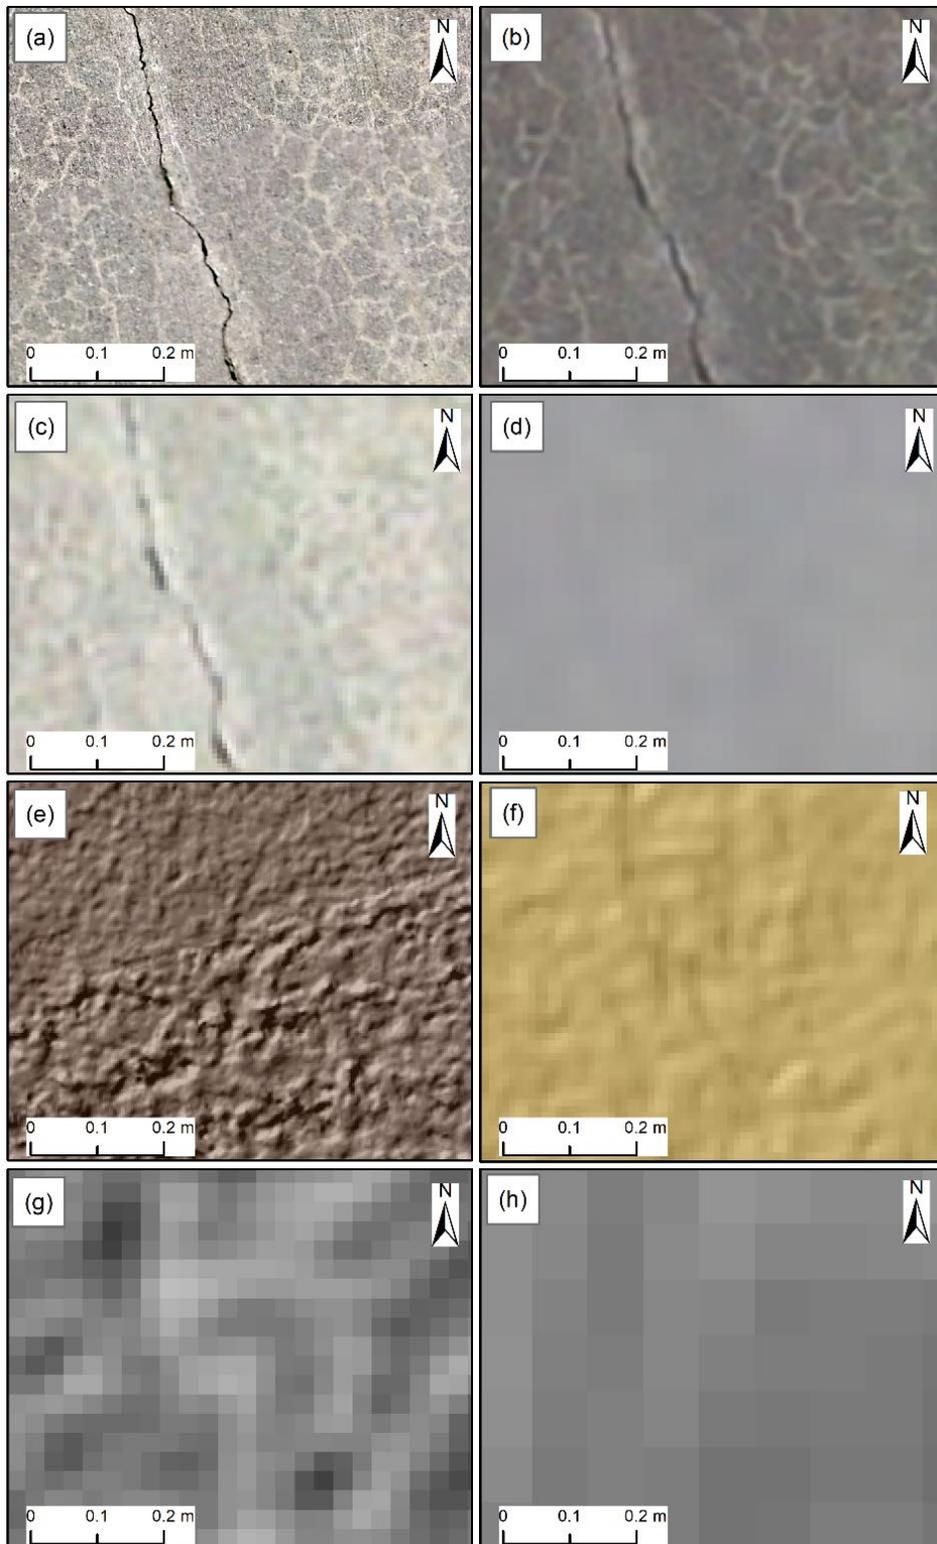
Figure 6. Low-severity LTD Cracking in (a) 0.8-mm/pix Orthophoto, (b) 2.5-mm/pix Orthophoto, (c) 7.2-mm/pix Orthophoto, (d) 21-mm/pix Orthophoto, (e) 3-mm/pix DEM, (f) 10-mm/pix DEM, (g) 29.1-mm/pix DEM, and (h) 84-mm/pix DEM

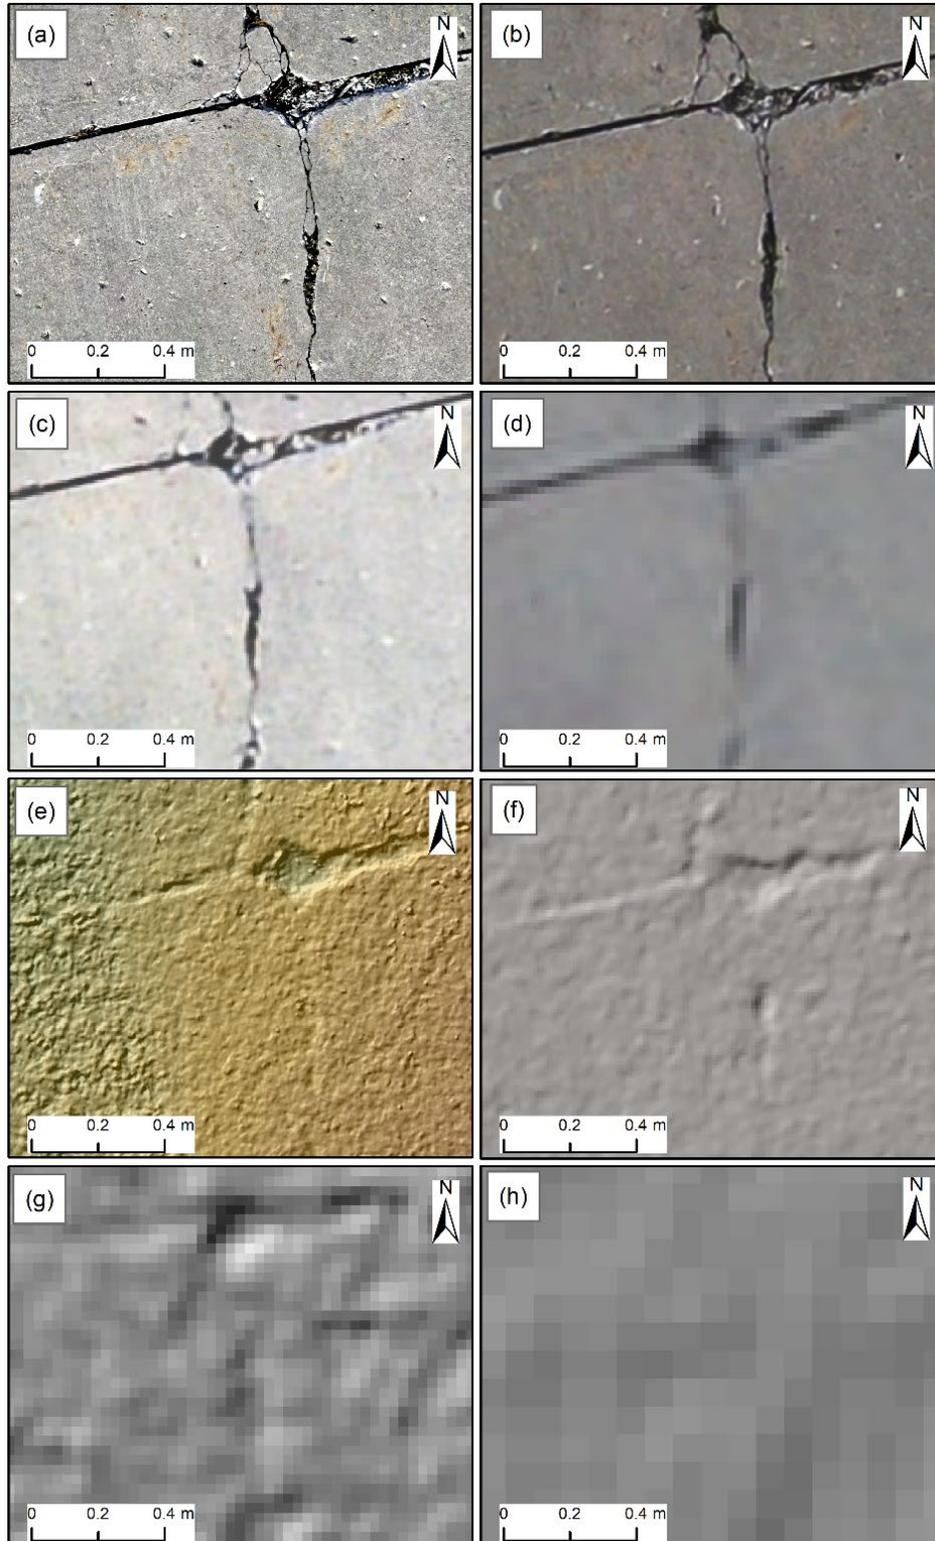
Figure 7. Medium-severity LTD Cracks and D-Cracking (M) in (a) 0.8-mm/pix Orthophoto, (b) 2.5-mm/pix Orthophoto, (c) 7.2-mm/pix Orthophoto, (d) 21-mm/pix Orthophoto, (e) 3-mm/pix DEM, (f) 10-mm/pix DEM, (g) 29.1-mm/pix DEM, and (h) 84-mm/pix DEM

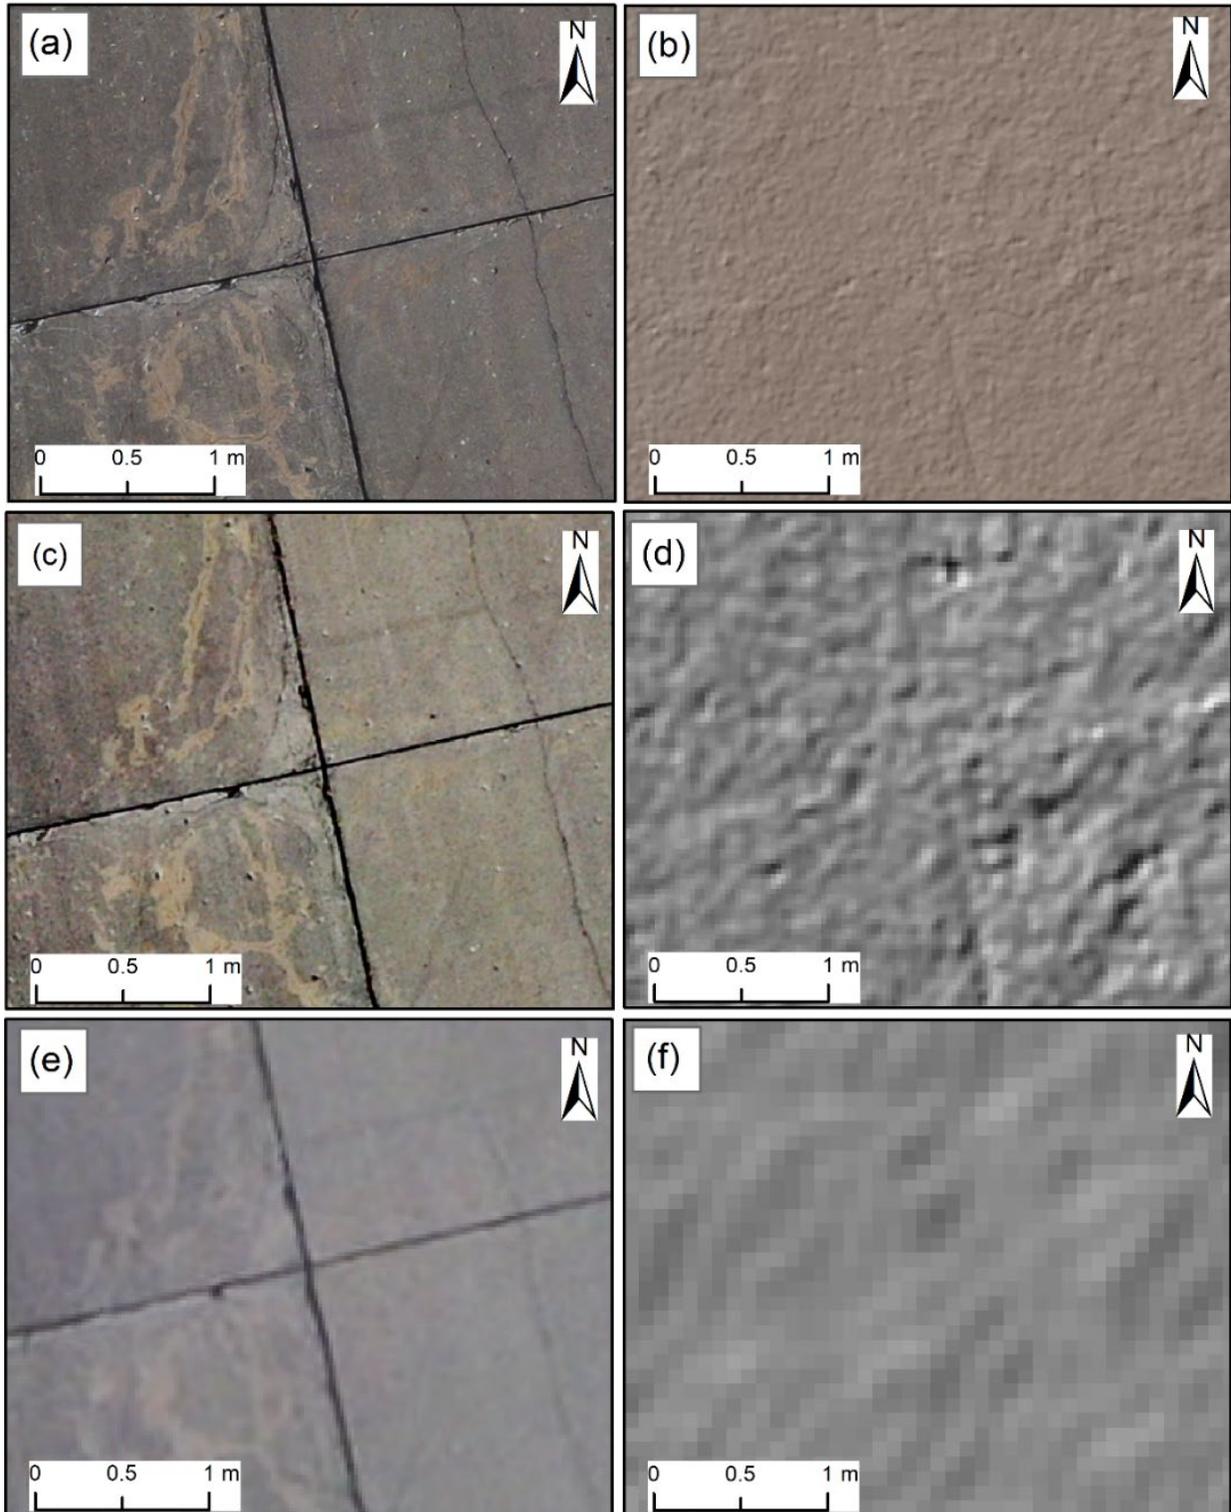
Figure 8. Low-severity D-Cracking, Low-severity ASR, and Medium-severity ASR in (a) 2.5-mm/pix Orthophoto, (b) 10-mm/pix DEM, (c) 7.2-mm/pix Orthophoto, (d) 29.1-mm/pix DEM, (e) 21-mm/pix Orthophoto, and (f) 84-mm/pix DEM

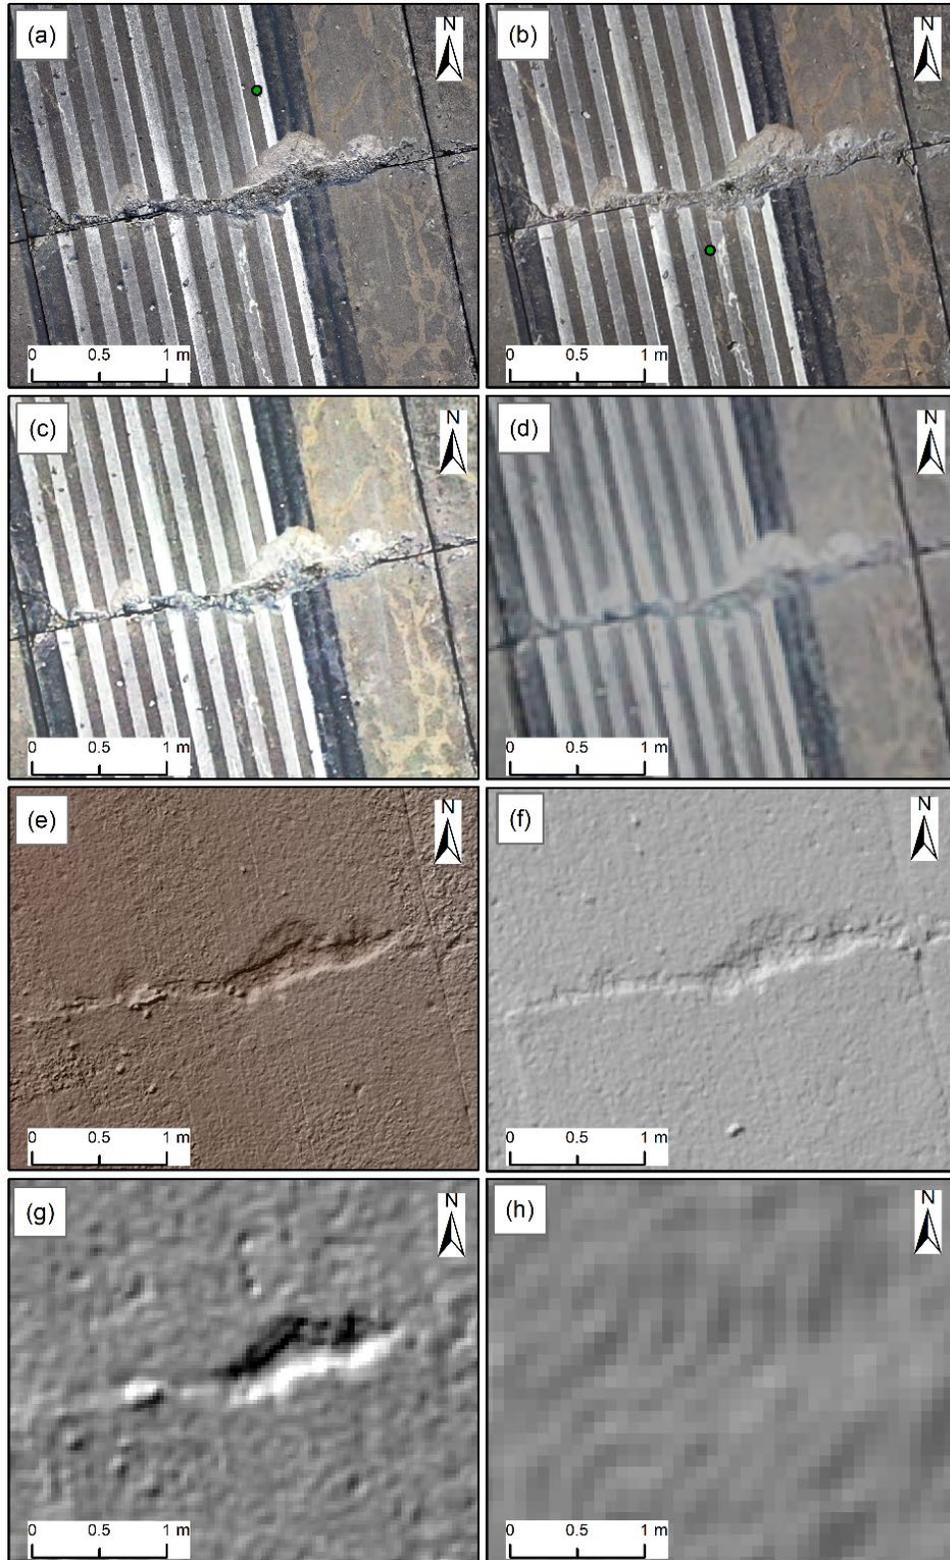
Figure 9. High-severity D-Cracking in (a) 0.8-mm/pix Orthophoto, (b) 2.5-mm/pix Orthophoto, (c) 7.2-mm/pix Orthophoto, (d) 21-mm/pix Orthophoto, (e) 3-mm/pix DEM, (f) 10-mm/pix DEM, (g) 29.1-mm/pix DEM, and (h) 84-mm/pix DEM

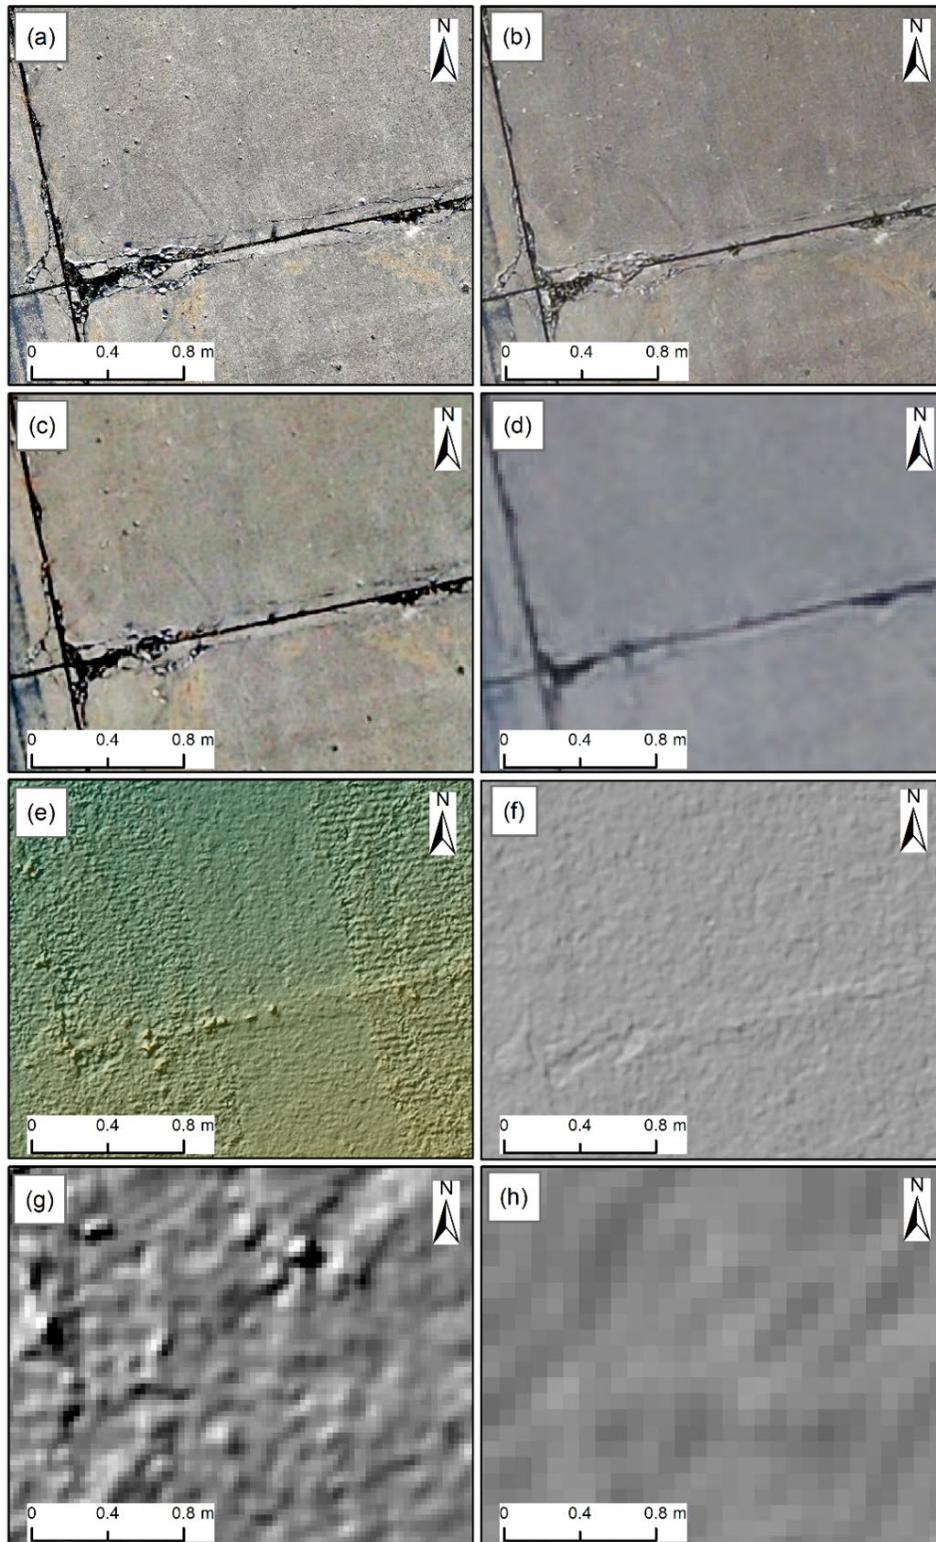
Figure 10. High-severity Joint Seal Damage in (a) 0.8-mm/pix Orthophoto, (b) 2.5-mm/pix Orthophoto, (c) 7.2-mm/pix Orthophoto, (d) 21-mm/pix Orthophoto, (e) 3-mm/pix DEM, (f) 10-mm/pix DEM, (g) 29.1-mm/pix DEM, and (h) 84-mm/pix DEM

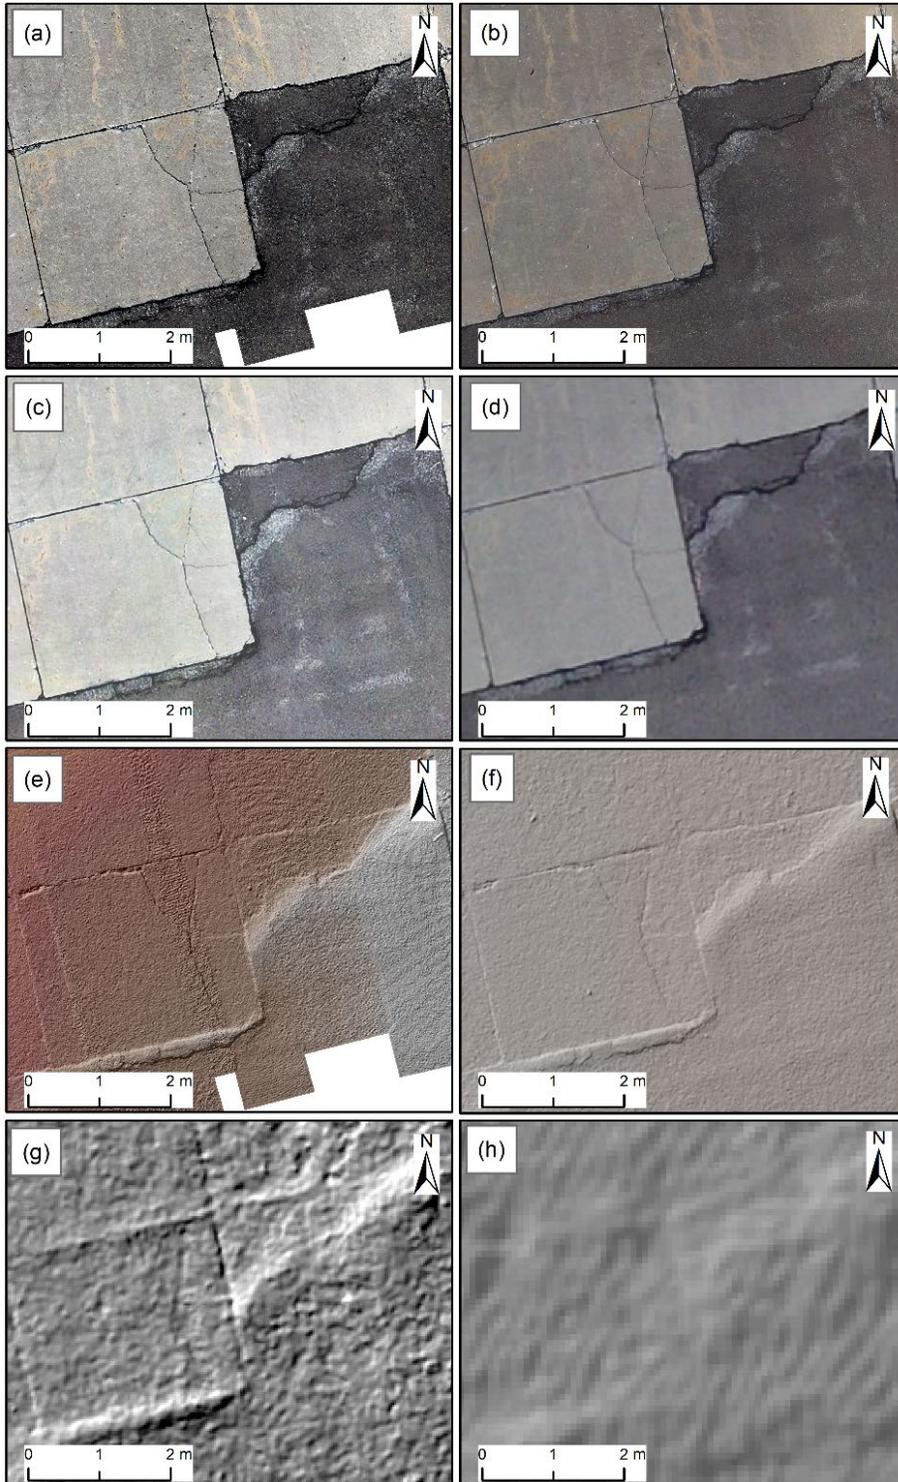
Figure 11. Medium-severity Shattered Slab, High-severity Large Patch , and Low-severity ASR in (a) 0.8-mm/pix Orthophoto, (b) 2.5-mm/pix Orthophoto, (c) 7.2-mm/pix Orthophoto, (d) 21-mm/pix Orthophoto, (e) 3-mm/pix DEM, (f) 10-mm/pix DEM, (g) 29.1-mm/pix DEM, and (h) 84-mm/pix DEM

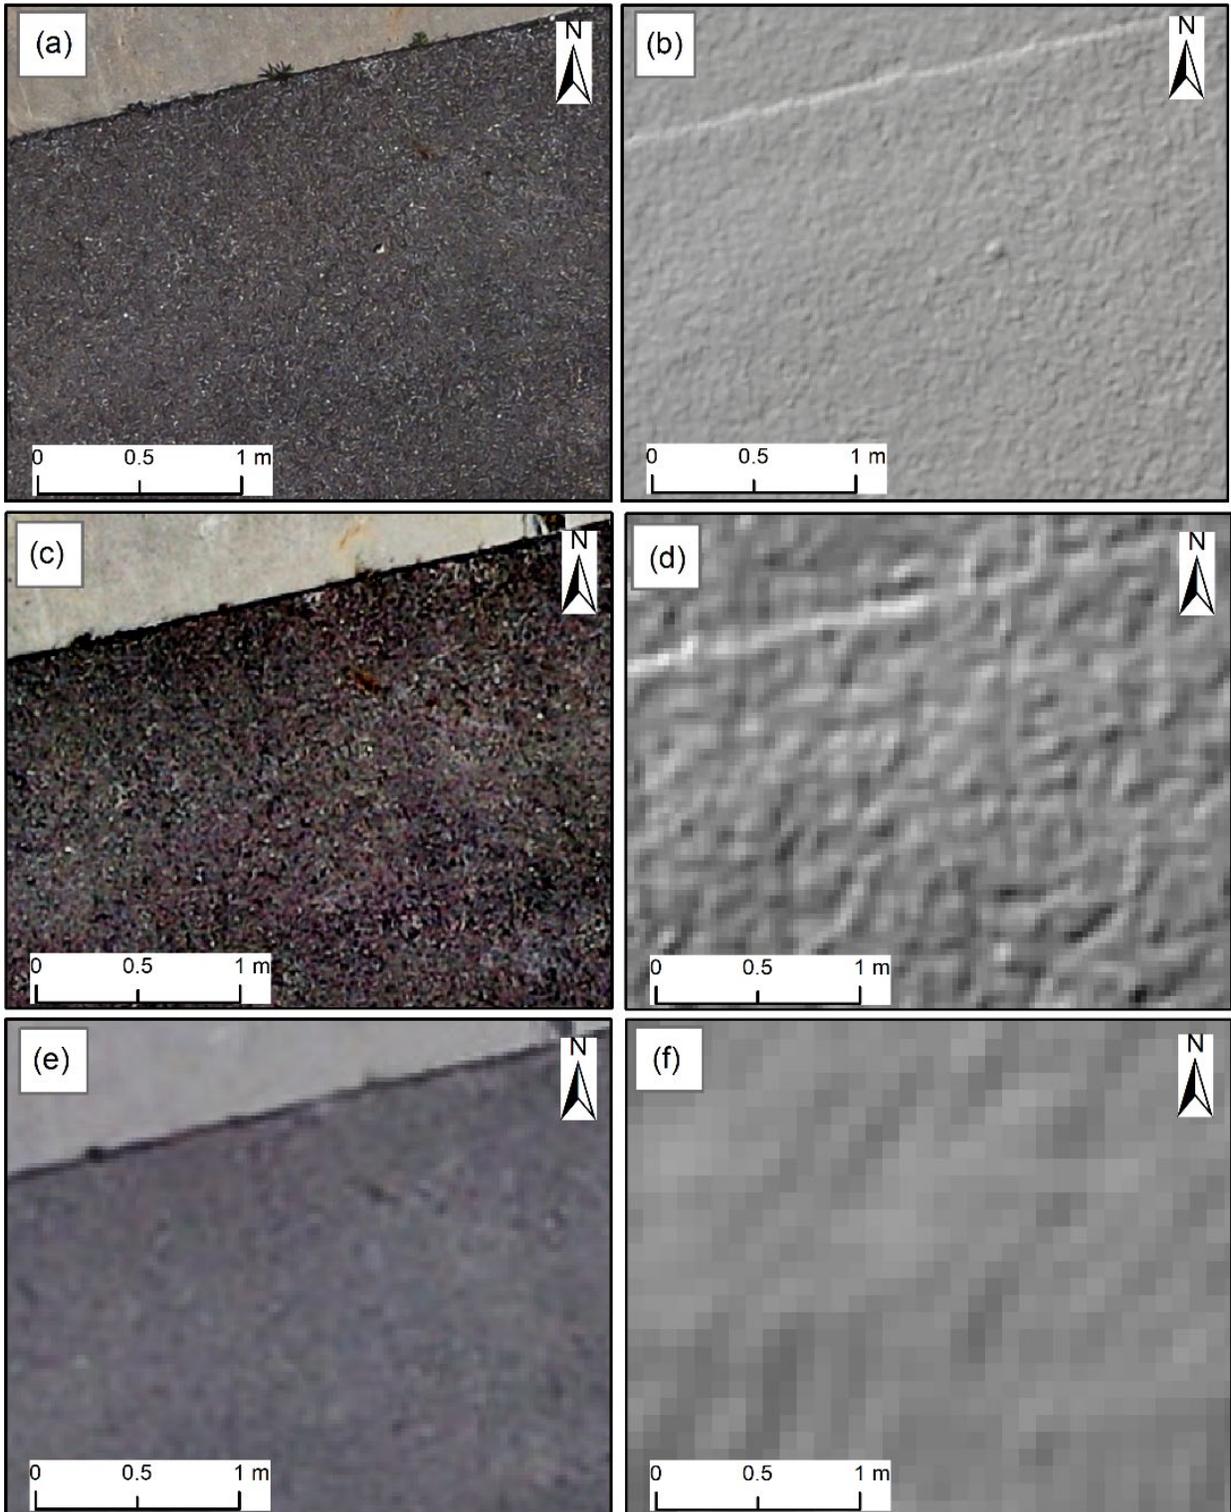
Figure 13. Low-severity Large Patching and High-severity Joint Seal Damage in (a) 2.5-mm/pix Orthophoto, (b) 10-mm/pix DEM, (c) 7.2-mm/pix Orthophoto, (d) 29.1-mm/pix DEM, (e) 21-mm/pix Orthophoto, and (f) 84-mm/pix DEM

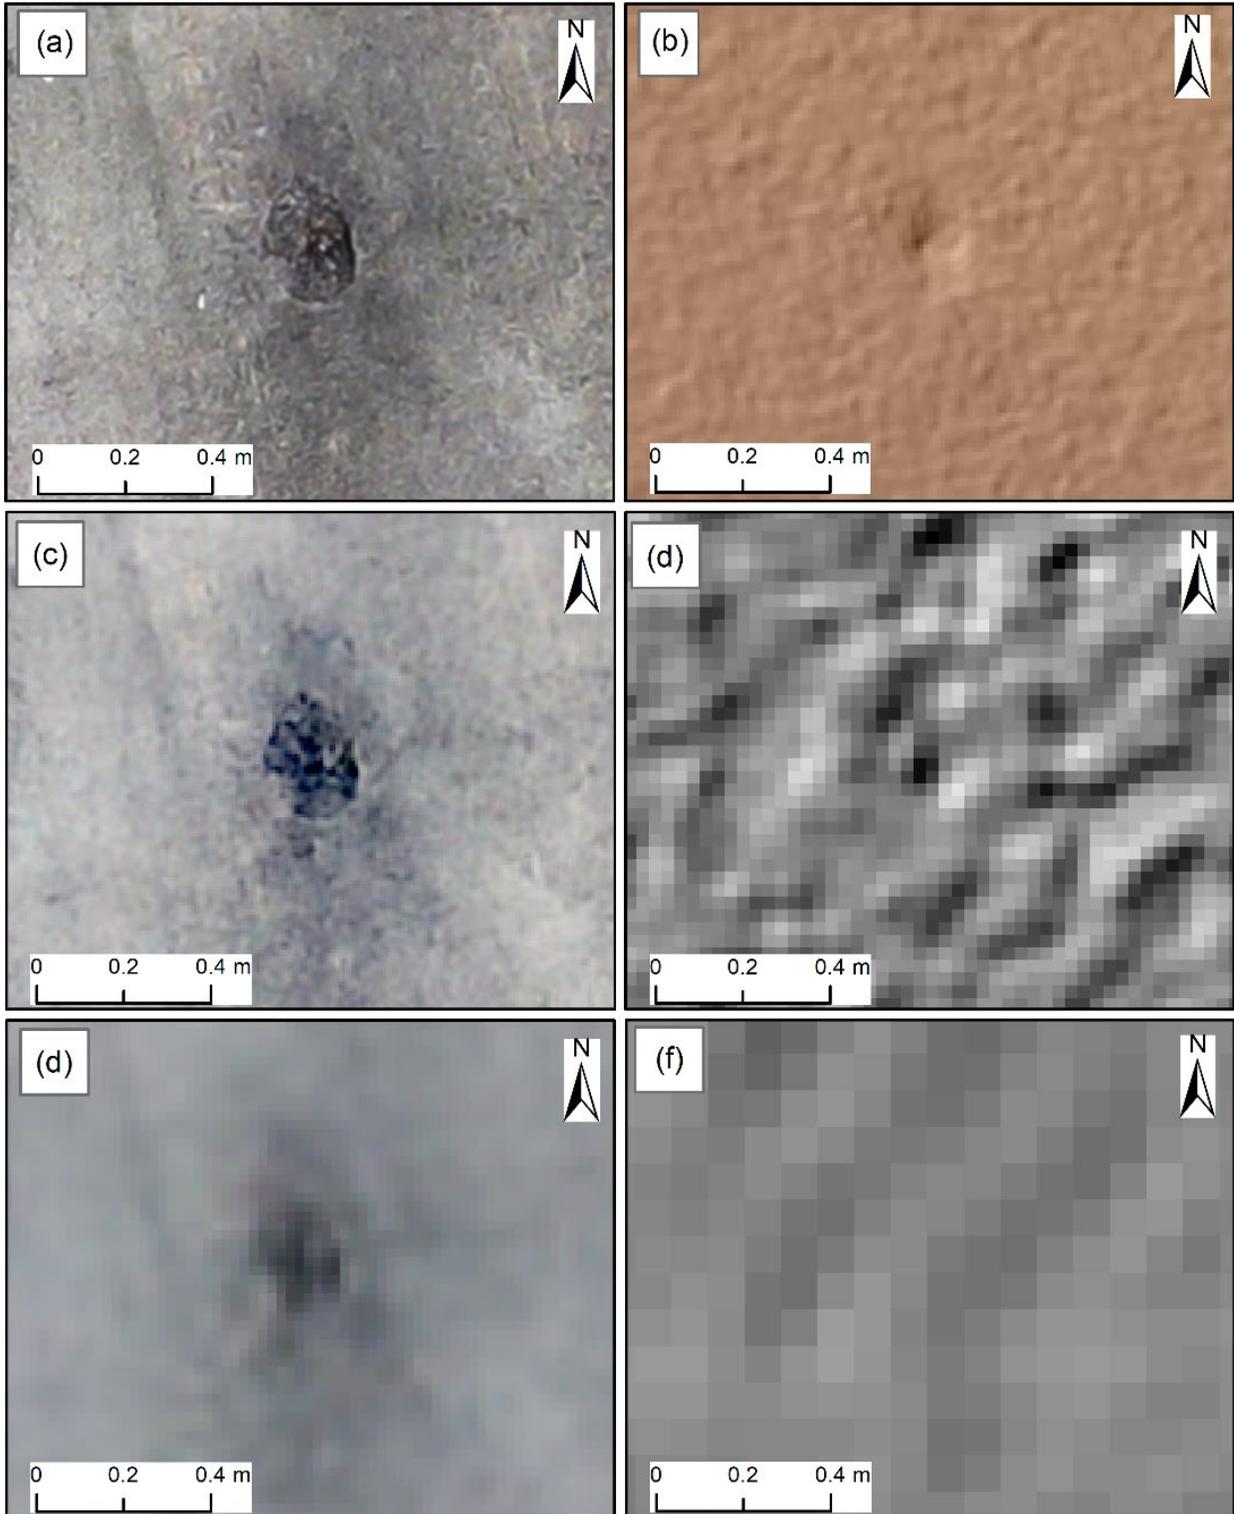
Figure 14. Medium-severity Scaling in (a) 2.5-mm/pix Orthophoto, (b) 10-mm/pix DEM, (c) 7.2-mm/pix Orthophoto, (d) 29.1-mm/pix DEM, (e) 21-mm/pix Orthophoto, and (f) 84-mm/pix DEM

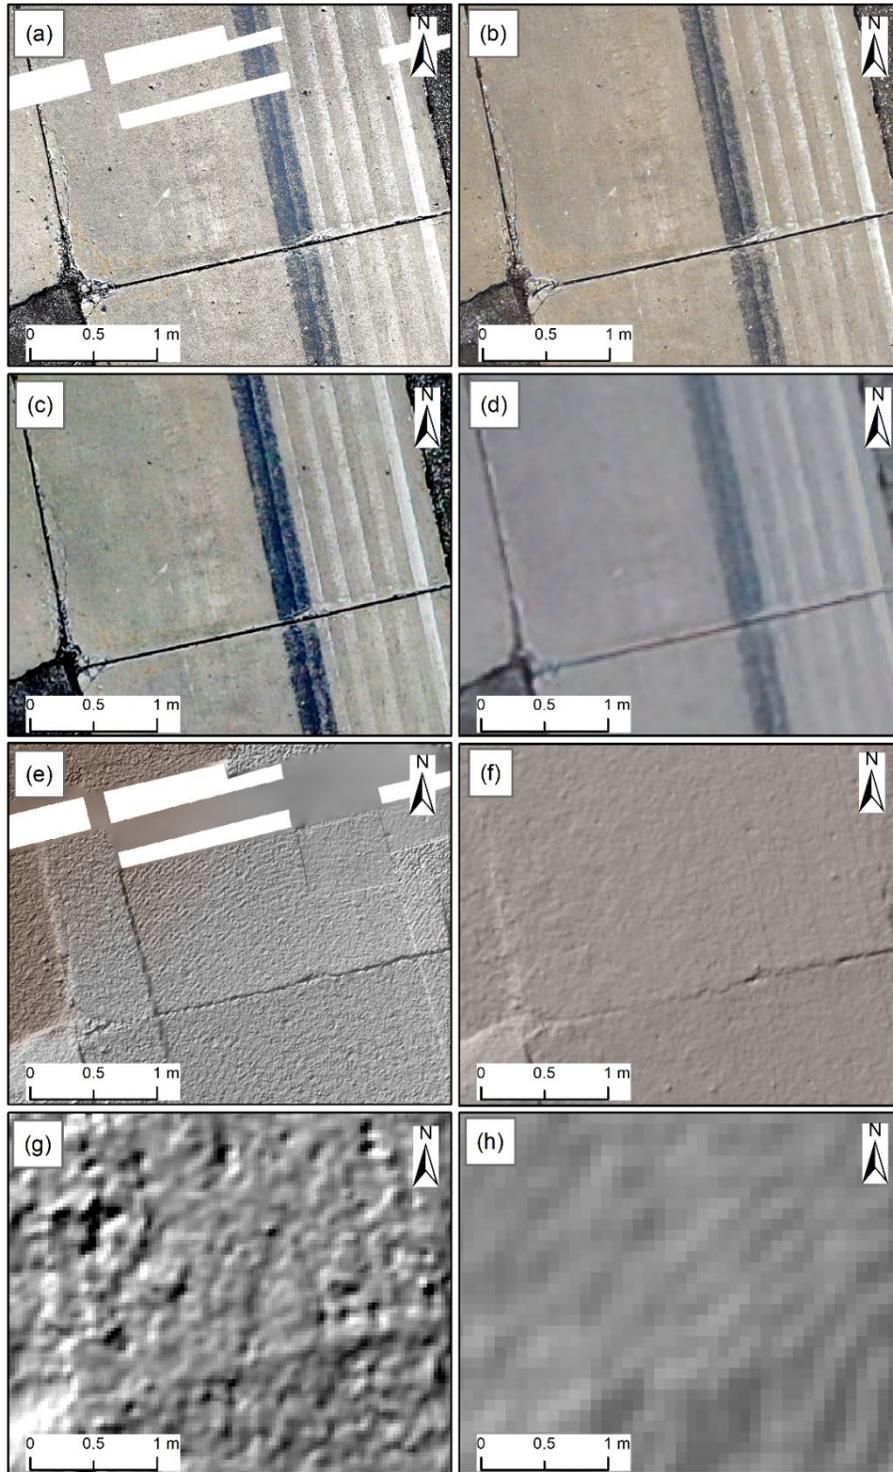
Figure 15. Medium-severity Faulting, Medium-severity D-Cracking in (a) 0.8-mm/pix Orthophoto, (b) 2.5-mm/pix Orthophoto, (c) 7.2-mm/pix Orthophoto, (d) 21-mm/pix Orthophoto, (e) 3-mm/pix DEM, (f) 10-mm/pix DEM, (g) 29.1-mm/pix DEM, and (h) 84-mm/pix DEM

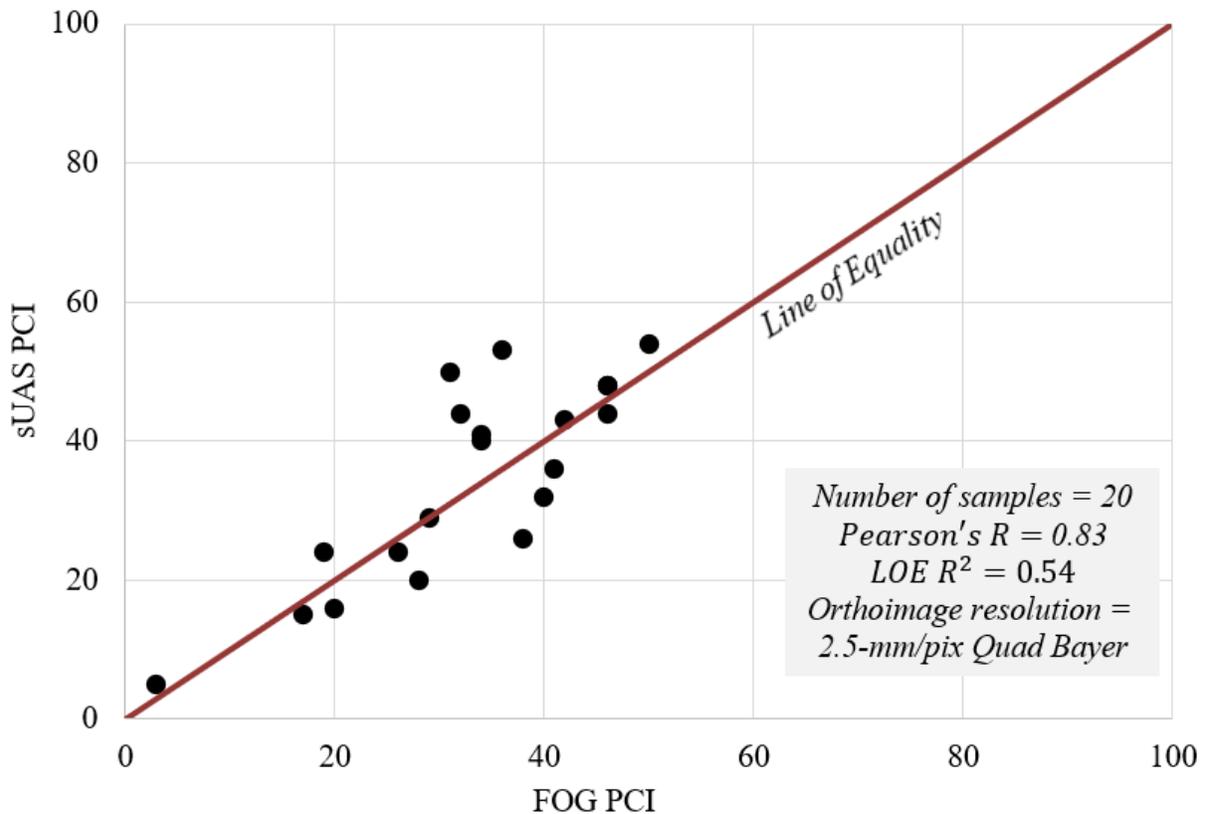
Figure 17. Foot-on-Ground PCI vs sUAS PCI Calculated Using 2.5-mm/pix Data from ONZ

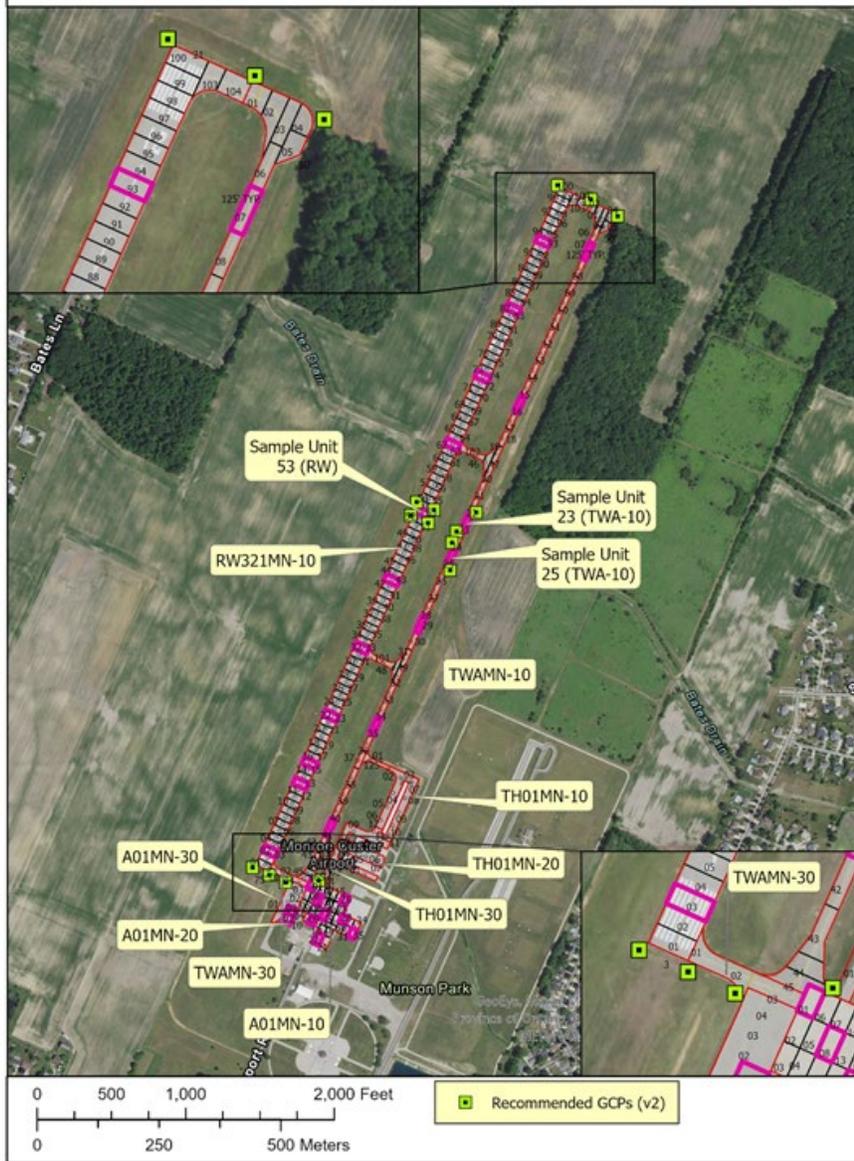
Figure 19. Sample Unit Focus Area and Recommended GCP Locations at TTF in March 2021

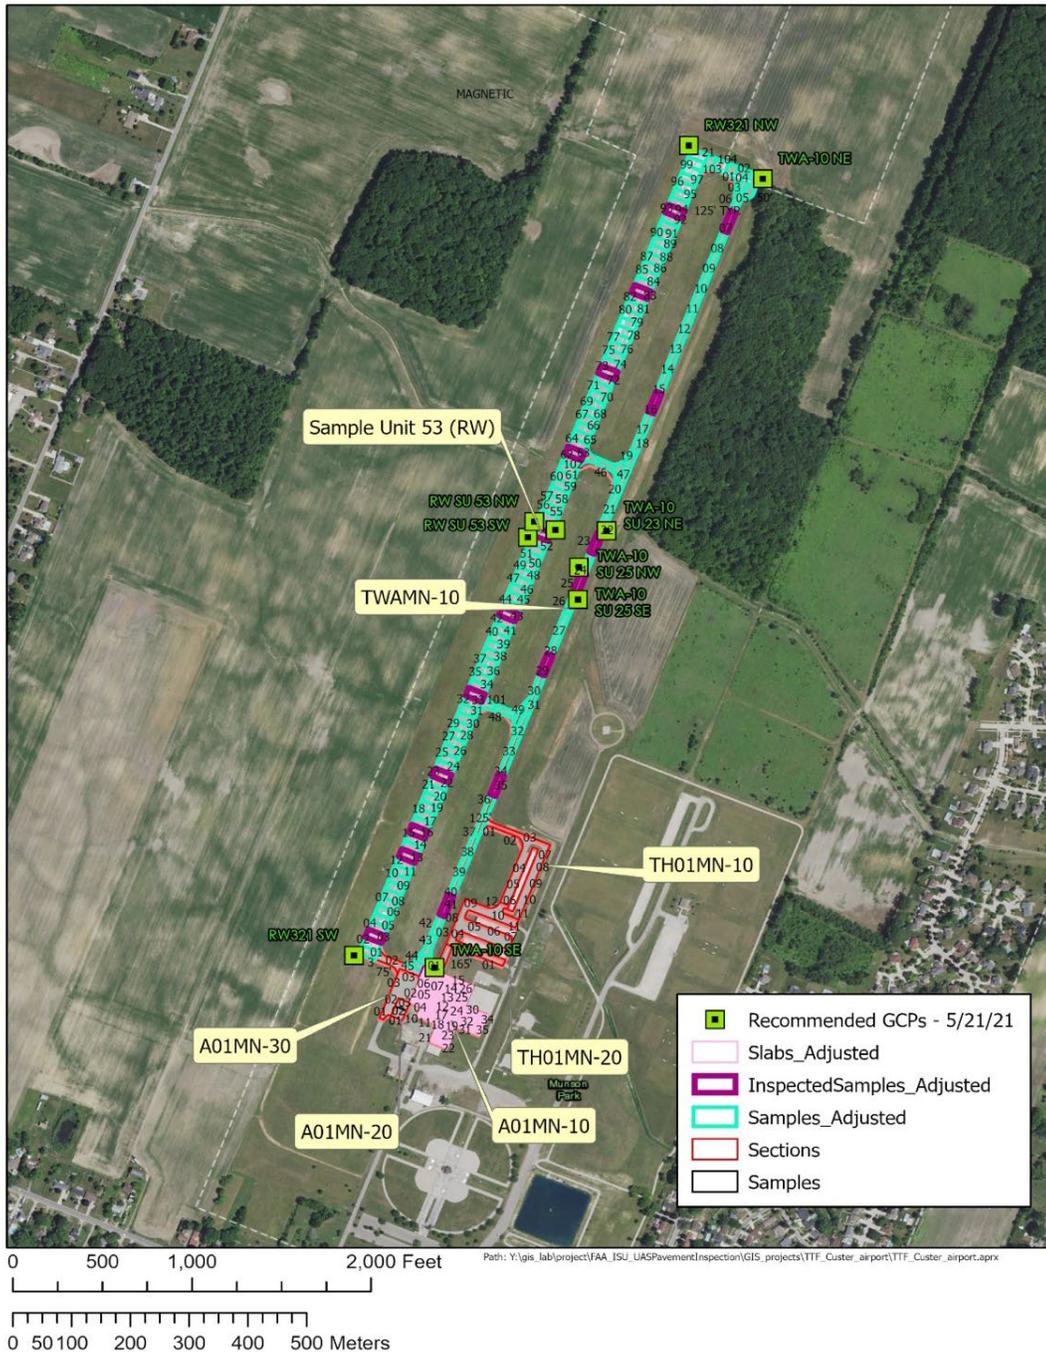
Figure 21. Sample Unit Focus Area and Recommended GCP Locations at TTF in May 2021

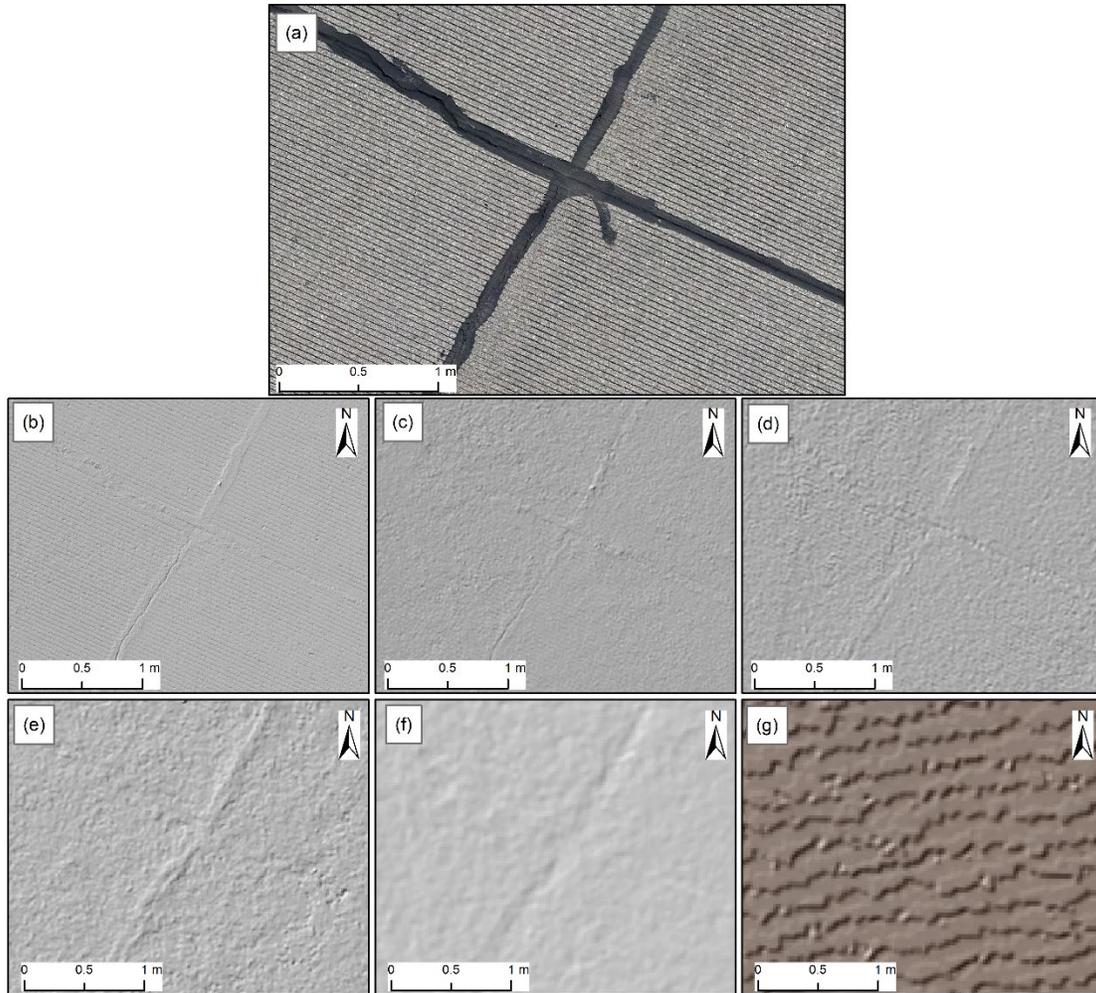
Figure 25. Low-severity Sealed L&T Cracks and Weathering on AAC Pavement at TTF: (a) 0.8-mm/pix Orthophoto, (b) 3-mm/pix DEM, (c) 6-mm/pix DEM, (d) 9.2-mm/pix DEM, (e) 10-mm/pix DEM, (f) 19.6-mm/pix DEM, and (g) 19.1-mm/pix DEM
